**Flood Control Project Maintenance
Levee Inspections**

Fall 2011 Levee Maintenance Deficiency Summary Report

Sacramento River Basin

Sacramento River West Side Levee District

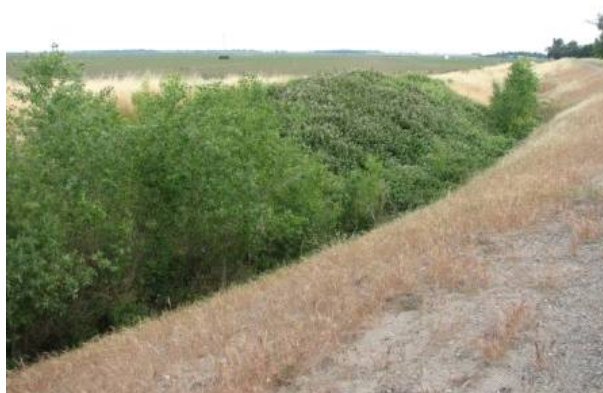
Levee Mile Report Line	1
Start Levee Mile	0.98
End Levee Mile	0.98
Location	Land Side
Category	Earthen Levee
Item	Vegetation

The photo shows vegetation at the toe of the levee. The willows have been cut.

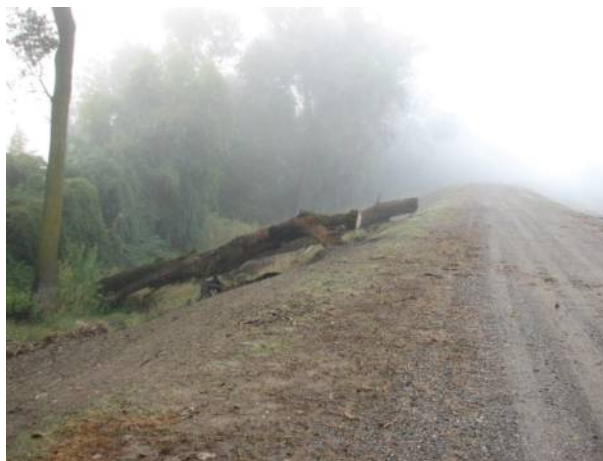
Levee Mile Report Line	2
Start Levee Mile	1.76
End Levee Mile	1.76
Location	Water Side
Category	Earthen Levee
Item	Encroachments

A tree has fallen down o the levee slope needs to be removed. Fall 2011

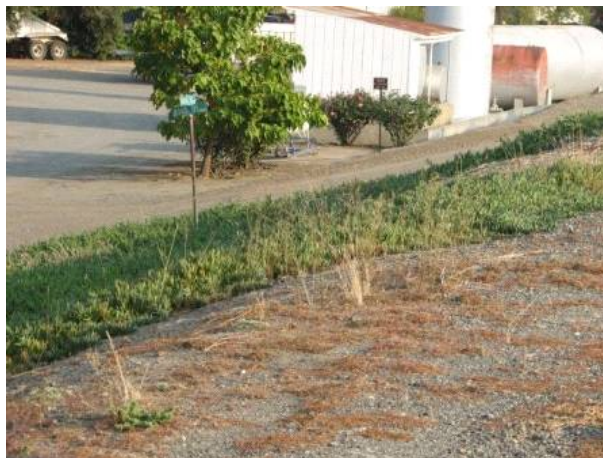
Levee Mile Report Line	4
Start Levee Mile	2.83
End Levee Mile	2.83
Location	Land Side
Category	Earthen Levee
Item	Encroachments

Landscape at River Garden Farms with irrigation.

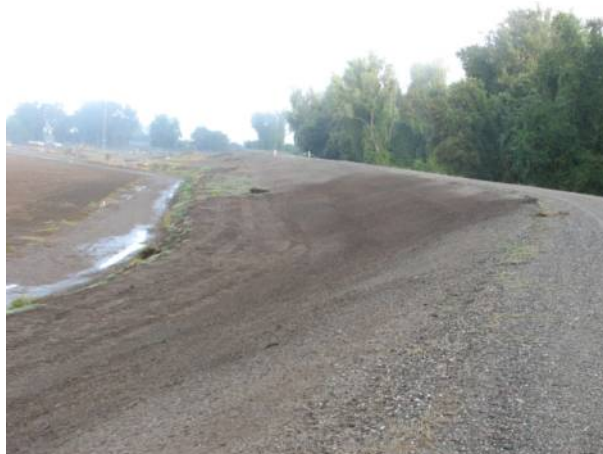
Levee Mile Report Line	7
Start Levee Mile	4.44
End Levee Mile	4.44
Location	Land Side
Category	Earthen Levee
Item	Slope Stability

The area from the PI inspection has been corrected Fall 2011.

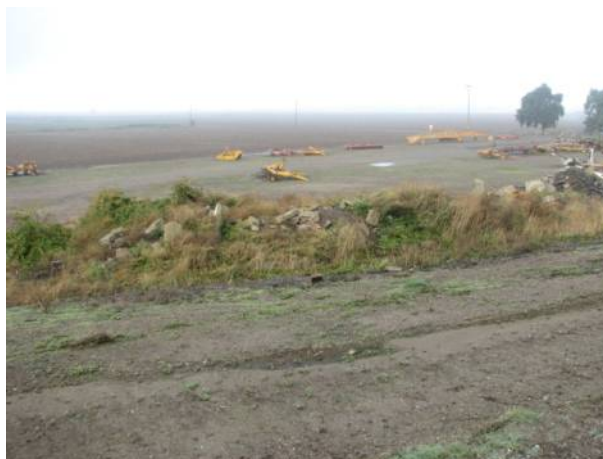
Levee Mile Report Line	8
Start Levee Mile	4.61
End Levee Mile	4.61
Location	Land Side
Category	Earthen Levee
Item	Encroachments

Concrete debris is piled along the toe of the levee. The district is removing it. Fall 2011.

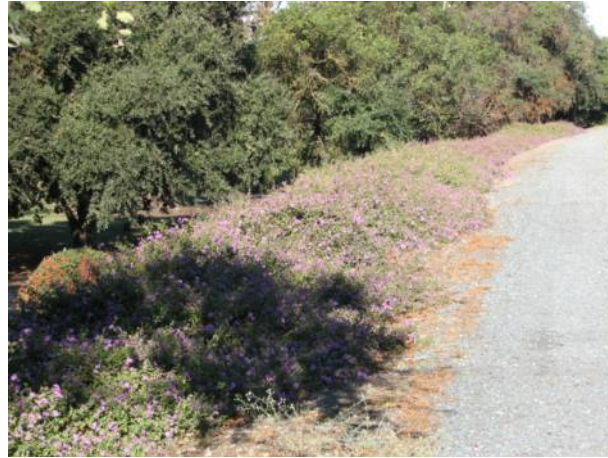
Levee Mile Report Line	18
Start Levee Mile	18.89
End Levee Mile	18.89
Location	Land Side
Category	Earthen Levee
Item	Encroachments

Groundcover and trees with irrigation are planted on the levee slope. Fall 2011.

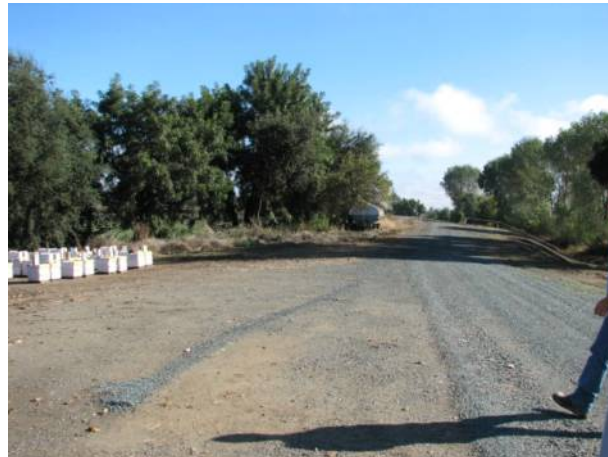
Levee Mile Report Line	22
Start Levee Mile	19.35
End Levee Mile	19.35
Location	Land Side
Category	Earthen Levee
Item	Encroachments

There is equipment on the levee crown and shoulder in the trees. Fall 2011.

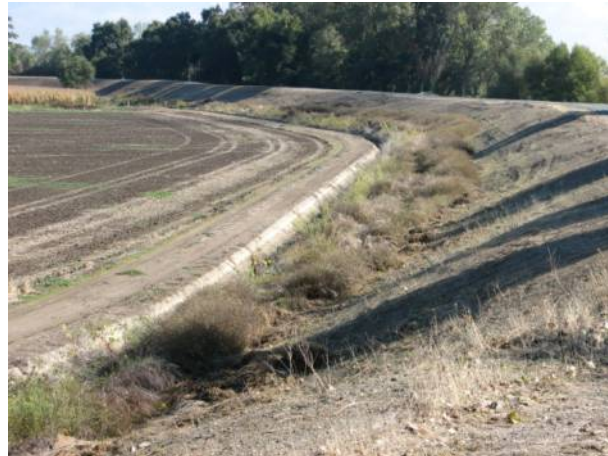
Levee Mile Report Line	23
Start Levee Mile	19.36
End Levee Mile	20.13
Location	Land Side
Category	Earthen Levee
Item	Encroachments

The concrete lined agricultural ditch runs along the toe. Fall 2011.

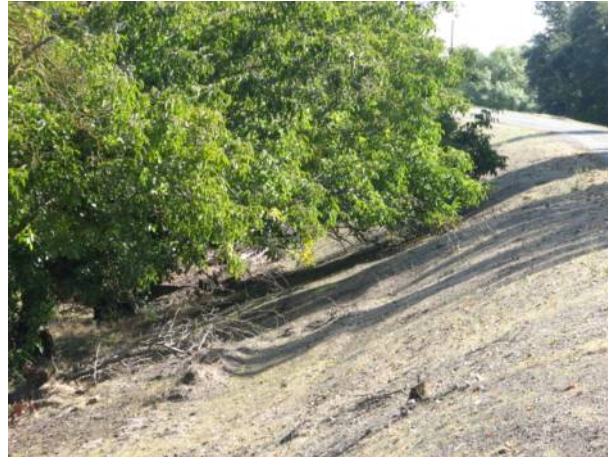
Levee Mile Report Line	25
Start Levee Mile	23.00
End Levee Mile	23.00
Location	Land Side
Category	Earthen Levee
Item	Trim / Thin Trees

The trees need to be trimmed up for visibilty. Fall 2011

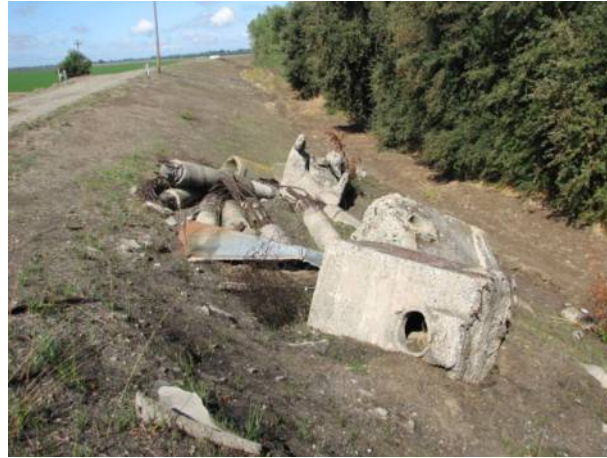
Concrete debris is on the waterside levee slope.
Fall 2011.

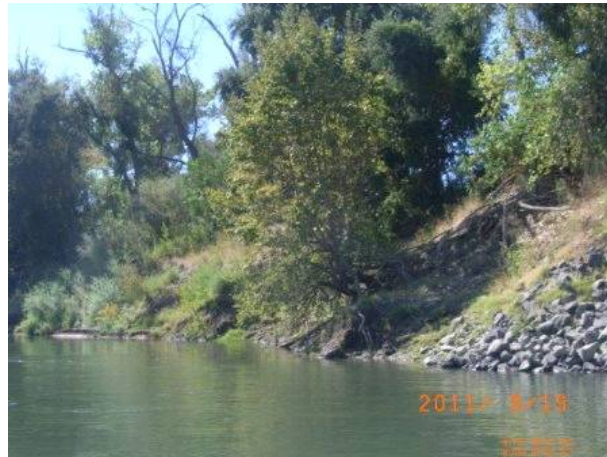
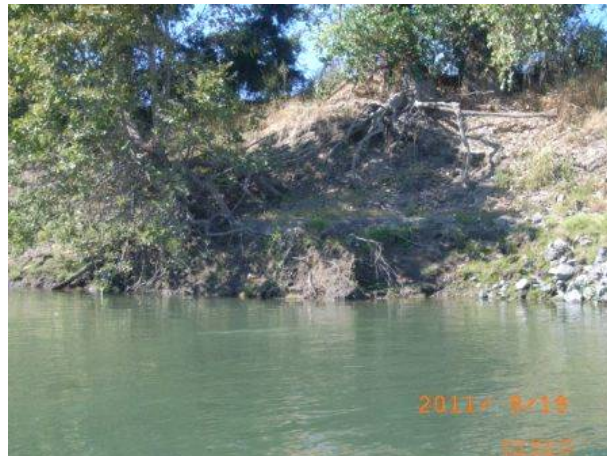
Levee Mile Report Line	36
Start Levee Mile	29.98
End Levee Mile	29.98
Location	Water Side
Category	Supplemental
Item	USACE Erosion Survey

36	29.98	29.98	Supplemental	USACE Erosion Survey	WS	M	Inspector Comments: 1997 - Mass failure of the lower cohesive bank and toe. 2000 - Still eroding, steeply dipping foresets in the toe are falling off. 2010 - Some new erosion and some new deposition. Eddy current off the upstream rock. 2011: Still plenty of berm left. [2011 Site ID: SAC_122-0_R]	39.063209 ° -121.838927 °	39.063997 ° -121.839335 °	10 Y
37	30.21	30.21	Supplemental	USACE Erosion Survey	WS	M	Inspector Comments: 2002 - Upstream end has recent slope failure and exposure of tree roots. 2003 - Some new minor slope erosion with new snags on the bank. 2004 - Appears a little worse. 2005 - Scallop in bank at the upstream end looks worse. 2009 - Minimal new erosion, Berm width is still large, but one large event or one fallen tree and it could go fast. 2010 - New erosion, bank is nearly all vertical from slumping. Site looks bad. 2011: site starting to look bad. [2011 Site ID: SAC_122-3_R]	39.065886 ° -121.842950 °	39.066287 ° -121.843602 °	11 Y

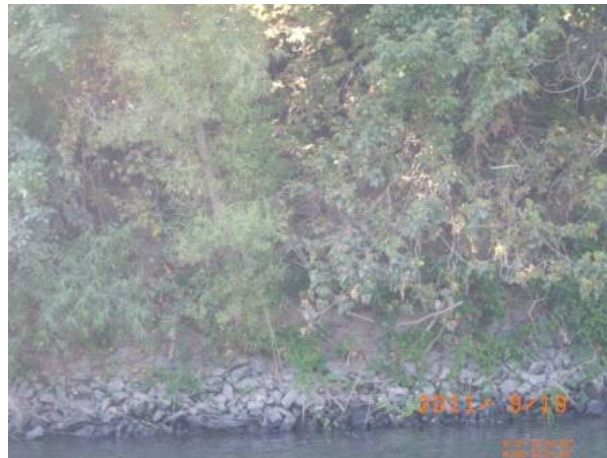
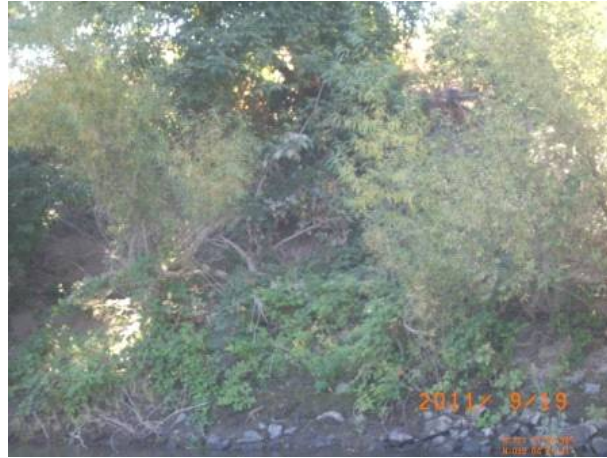
Levee Mile Report Line	38
Start Levee Mile	31.76
End Levee Mile	31.78
Location	Water Side
Category	Supplemental
Item	USACE Erosion Survey

38	31.76	31.78	Supplemental	USACE Erosion Survey	WS	M	Inspector Comments: 1997 - Erosion into the levee section; old concrete rubble loss at toe; transition between the rock upstream and the cobble downstream. 2000 - Cohesive bench with concrete slabs on top; 25 ft deep scour hole on the downstream end. 2011: No observed change. [2011 Site ID: SAC_123-7_R]	39.066901 ° -121.867322 °	39.067004 ° -121.866913 °	12 Y
39	32.01	32.01	Earthen Levee	Encroachments	WS	PO	Buildings Inspector Comments: Old concrete pumphouse on shoulder open needs to be sealed up.	39.066147 ° -121.870425 °	39.066147 ° -121.870425 °	60 Y
40	32.42	32.42	Earthen Levee	Vegetation	WS	W	Elderberries are blocking visibility and flood fight capability.	39.069130 ° -121.876638 °	39.069130 ° -121.876638 °	41
41	32.43	32.56	Earthen Levee	Encroachments	WS	PO	Buildings Inspector Comments: Grimes Boat Landing	39.069487 ° -121.876817 °	39.070063 ° -121.879062 °	42

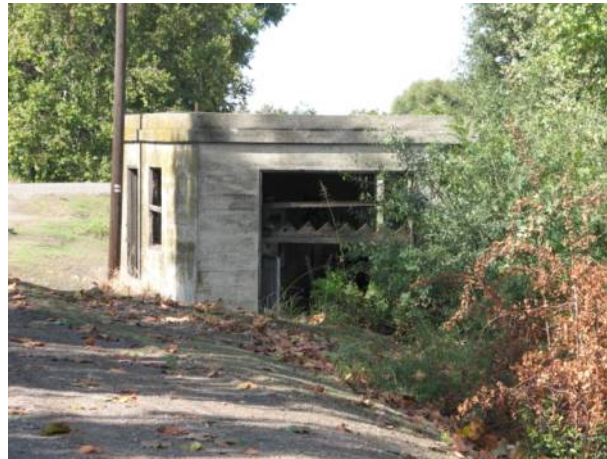
Levee Mile Report Line	39
Start Levee Mile	32.01
End Levee Mile	32.01
Location	Water Side
Category	Earthen Levee
Item	Encroachments

Old concrete pump house on the waterside levee slope. Fall 2011.

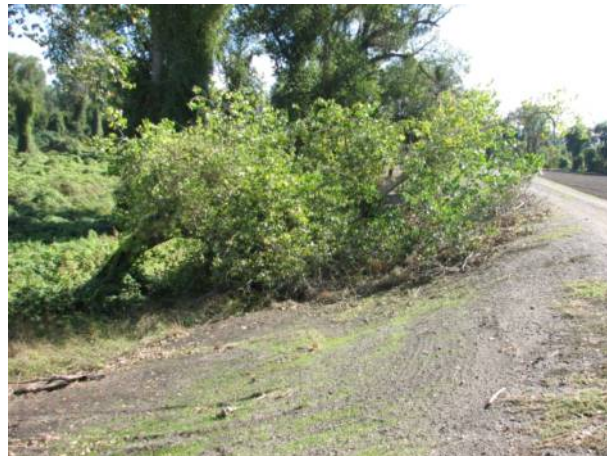
Levee Mile Report Line	45
Start Levee Mile	35.47
End Levee Mile	35.47
Location	Water Side
Category	Earthen Levee
Item	Trim / Thin Trees

The tree has fallen down on the levee slope. Fall 2011.

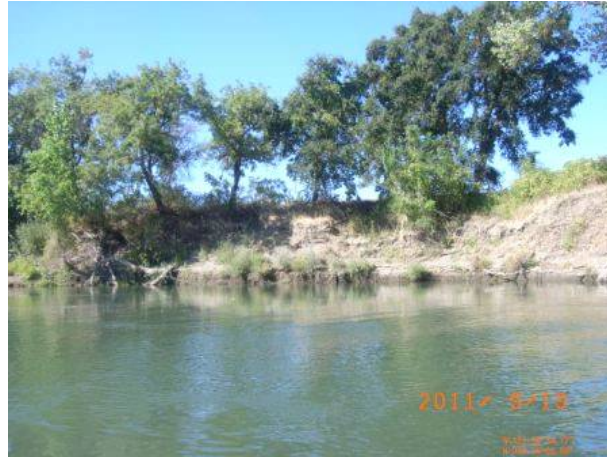
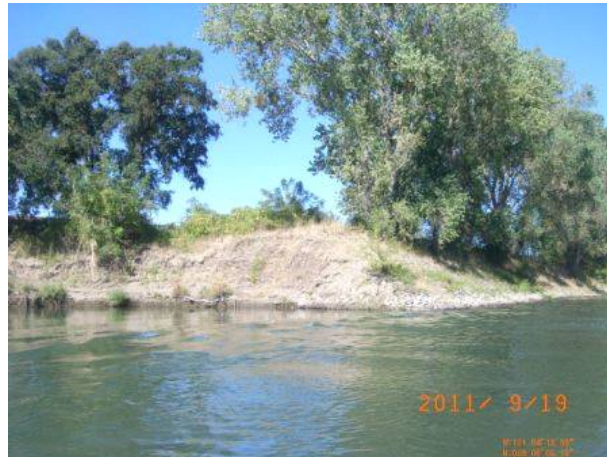
Levee Mile Report Line	46
Start Levee Mile	35.62
End Levee Mile	35.62
Location	Water Side
Category	Supplemental
Item	USACE Erosion Survey

46	35.62	35.62	Supplemental	USACE Erosion Survey	WS	M	Inspector Comments: 1997 - Major scour off the downstream end of existing rock, creating a scour pocket where the levee starts diverging from the bankline. 2000 - Some minor erosion, 20 ft deep hole at downstream end. 2004 - Small amount of new erosion. 2010 - Bad transition off downstream end of rock revetment, some new erosion. 2011: No observed change. [2011 Site ID: SAC_127-9_R]	39.100084 ° -121.903981 °	39.100836 ° -121.904320 °	17 Y
47	42.85	43.02	Earthen Levee	Vegetation	LS	M	Remove the wild growth other than native grasses from the levee slopes. Inspector Comments: Johnson grass is progressing and is getting densier.	39.164373 ° -121.936867 °	39.166666 ° -121.937674 °	1430 Y
48	43.35	43.35	Supplemental	USACE Erosion Survey	WS	M	Inspector Comments: 2010 - Lower portion of 136.7 that did not extend far enough. Abrupt transition from upstream site. 2011: No observed change. [2011 Site ID: SAC_136-6_R]	39.173245 ° -121.939419 °	39.174555 ° -121.940427 °	19 Y

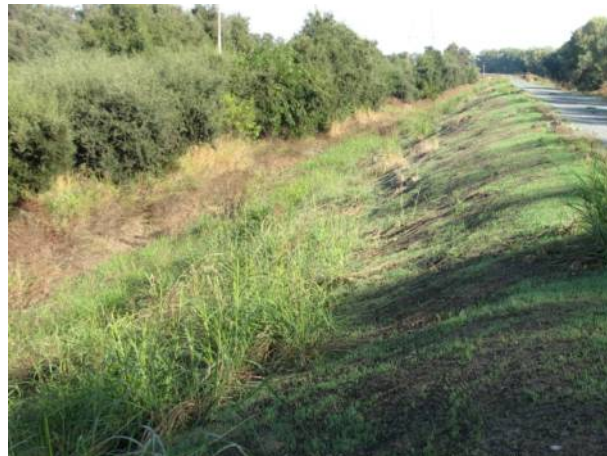
Levee Mile Report Line	47
Start Levee Mile	42.85
End Levee Mile	43.02
Location	Land Side
Category	Earthen Levee
Item	Vegetation

Johnson grass is taller than 12 inches. Fall 2011.

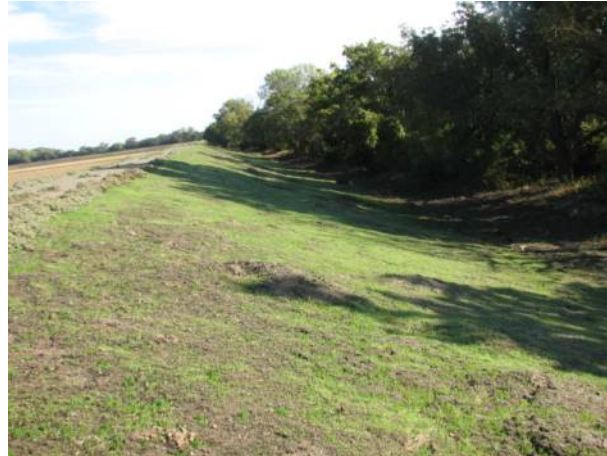
Levee Mile Report Line	52
Start Levee Mile	44.28
End Levee Mile	44.28
Location	Water Side
Category	Earthen Levee
Item	Animal Control
Rodent mounds on the waterside several in the area. Fall 2011.	
johngw_f_20111024_413.jpg

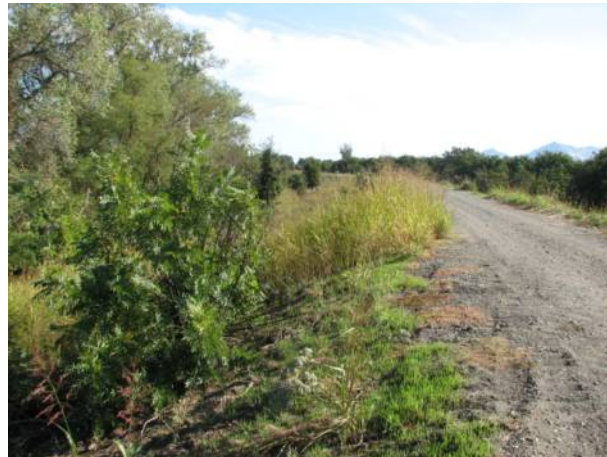
Levee Mile Report Line	55
Start Levee Mile	46.56
End Levee Mile	46.56
Location	Water Side
Category	Earthen Levee
Item	Vegetation
The Johnson grass is taller then 12 inches. Fall 2011.	
johngw_f_20111024_414.jpg

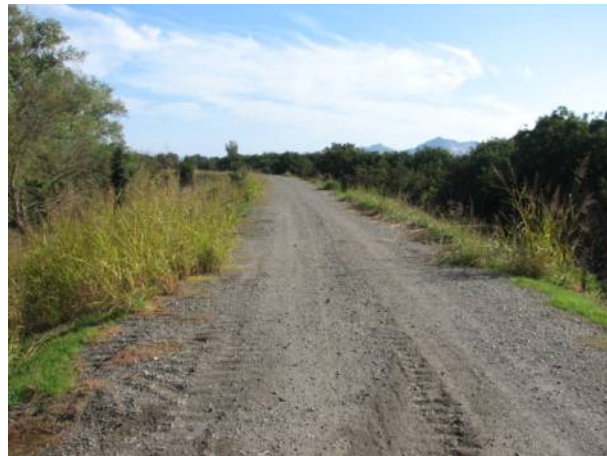
Levee Mile Report Line	55
Start Levee Mile	46.56
End Levee Mile	46.56
Location	Water Side
Category	Earthen Levee
Item	Vegetation
The Johnson grass is taller then 12 inches. Fall 2011.	
johngw_f_20111024_415.jpg

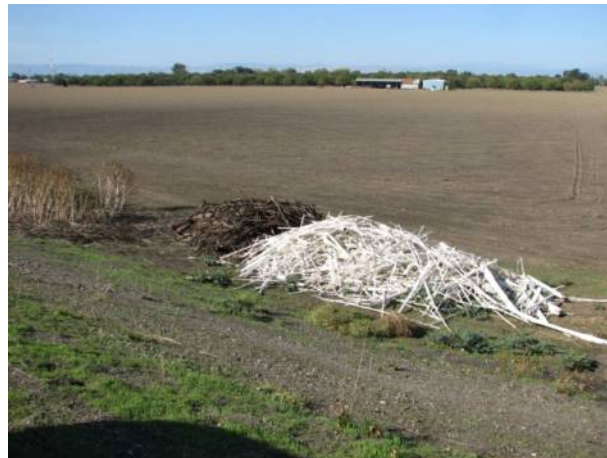
Levee Mile Report Line	58
Start Levee Mile	48.82
End Levee Mile	48.82
Location	Land Side
Category	Earthen Levee
Item	Encroachments

Old irrigation pipe is piled up on the toe of the levee. Fall 2011.

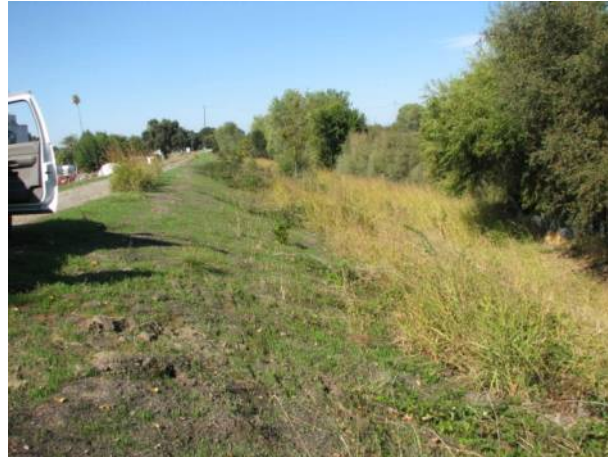
The vegetation is taller than 12 inches and above the 20 foot line. Fall 2011.
